**Flood Control Project Maintenance  
Levee Inspections**

**Fall 2016 Levee Maintenance Deficiency Summary Report**

***San Joaquin River Basin***

**Reclamation District No. 2062 Stewart**

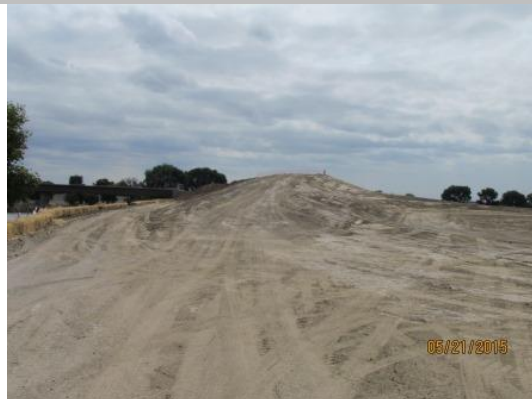
Photo 1 of 1 : FA\_2016\_RD2062\_309\_6\_20160914\_00001.jpg

View of the new patrol road installation in process.

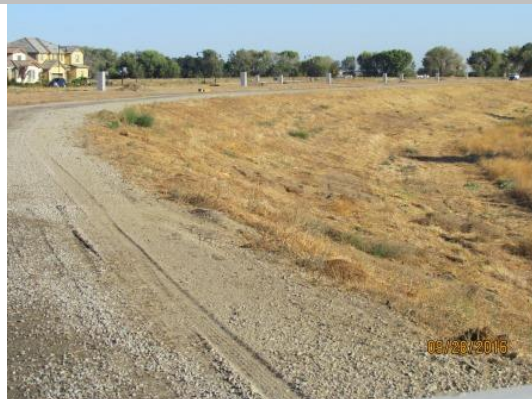
Photo 1 of 1 : FA\_2016\_RD2062\_309\_7\_20160929\_00011.jpg

LM Start	1.27	Rating **	A	Issue No.	7
LM End	2.52	Issue Type +	Ma	Location *	WS
Category	Earthen Levee			GPS Latitude/Longitude	
				Start	End
Item	Vegetation			37.798538 °	37.788692 °
				-121.313634 °	-121.308827 °
DWR ID	DWR_RD2062_01_f_2016_7				
Comment Code					
V1 : Control annual grass and weeds on the levee slopes and easements.					
Inspector Comment					
LMA has a good vegetation control program.

View of the vegetation on the waterside levee slope.

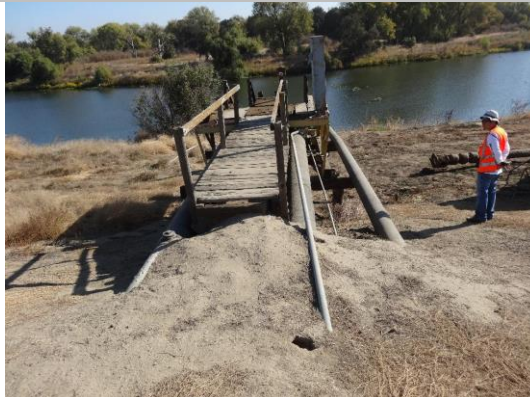
Photo 2 of 2 : UCIP\_FA\_2016\_22807\_38904.jpg

WS view: 16-inch pipes on both sides of walkway and 10-inch pipe (on right) away from walkway.

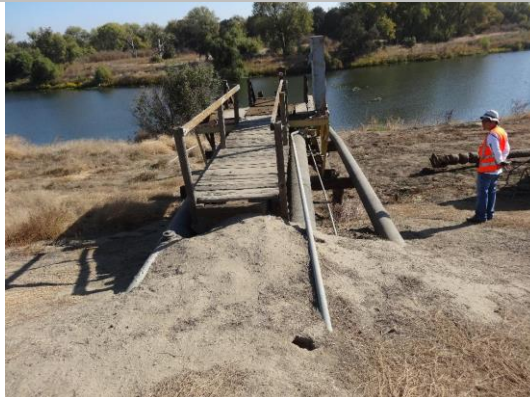
Photo 2 of 2 : UCIP\_FA\_2016\_22809\_38912.jpg

WS view: 16-inch pipes on both sides of walkway and 10-inch pipe (on right) away from walkway.

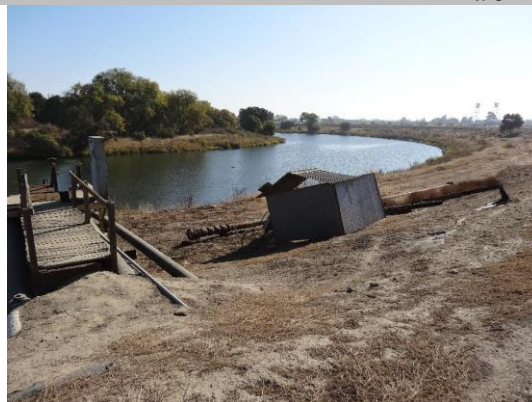
Photo 2 of 2 : UCIP\_FA\_2016\_22810\_38917.jpg

WS view: electric conduit and 10-inch pipe (right). Dismantled/removed pipe and pump house (far right).

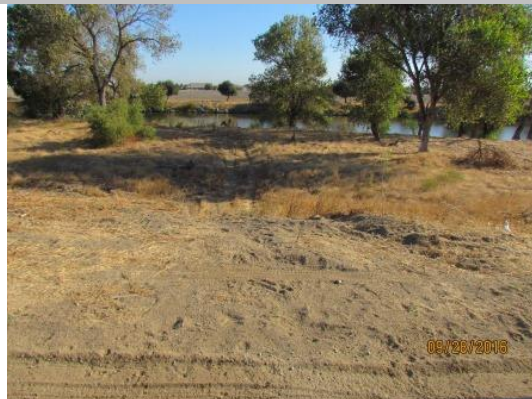
Photo 1 of 1 : FA\_2016\_RD2062\_309\_9\_20160929\_00012.jpg

LM Start	2.14	Rating **	M	Issue No.	9
LM End	2.14	Issue Type +	Ma	Location *	WS
Category	Earthen Levee			GPS Latitude/Longitude	
				Start	End
Item	Slope Stability			37.793991 °	37.793991 °
				-121.308524 °	-121.308524 °
DWR ID	DWR_RD2062_01_f_2016_9				
Comment Code					
S3 : Repair the levee slope damaged by vehicle traffic and prevent access where possible.					
Inspector Comment					
It is recommended to control levee access to prevent possible future damage to the levee slopes.

View of the waterside levee slope erosion due to vehicles driving on the slope.

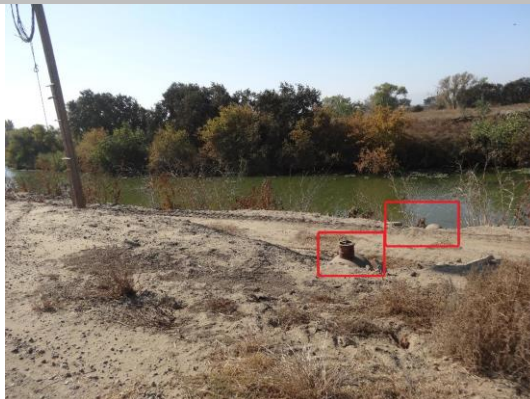
Photo 1 of 2 : UCIP\_FA\_2016\_23110\_39398.jpg

LM Start	0.56	Rating **	M	Issue No.	20
LM End	0.56	Issue Type +	En	Location *	WS
Category	Supplemental			GPS Latitude/Longitude	
				Start	End
Item	DWR UCIP Field Study			37.784380 °	37.784380 °
				-121.338985 °	-121.338985 °
DWR ID					
Comment Code					
Inspector Comment					
FS_ID:23110					
DS_ID:24697					
EP_NO: N/A					
Repair Type: Non-Urgent					
Crossing Status: Found					
UCIP Comments: Found on field with the help of USACE 2012 PI					
Report.Needs proper abandonment.					
FIELD_STRUCT_DESC: Abandoned 24-inch steel pipe through the					
levee. Damaged siphon breaker on waterside levee slope. Pump on					
concrete sump on landside. Service pole on landside levee slope.					
Pump was disconnected from service pole.					
FS Date: 10/23/2013

WS view: power pole (left), siphon breaker (marked- left), and steel pipe (right) on levee slope.

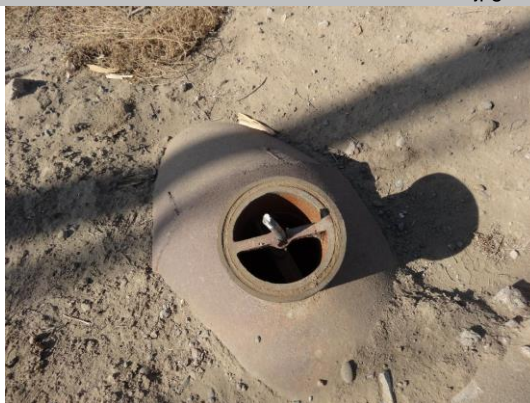
Photo 2 of 2 : UCIP\_FA\_2016\_23110\_39397.jpg

WS view: exposed steel pipe and damaged siphon breaker on levee slope.

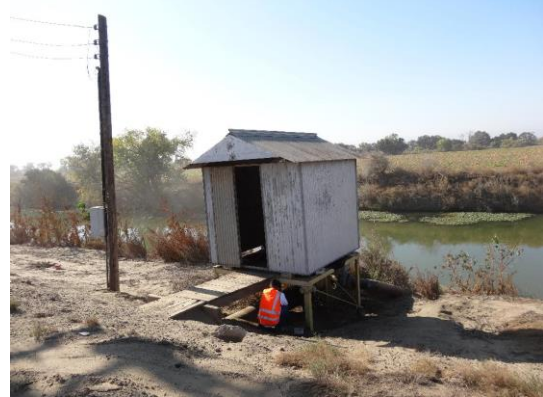
Photo 1 of 2 : UCIP\_FA\_2016\_23181\_39792.jpg

WS view: pipe, walkway, service pole, and pumphouse on levee slope.

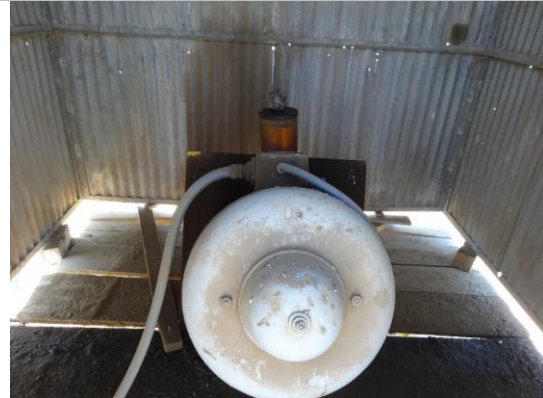
Photo 2 of 2 : UCIP\_FA\_2016\_23181\_39791.jpg

WS view: leaky slant pump in pumphouse on levee slope.

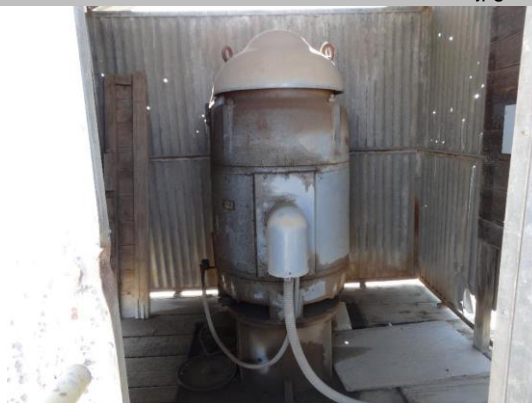
Photo 2 of 2 : UCIP\_FA\_2016\_23062\_39194.jpg

WS view: leaky pump and control box in pumphouse.

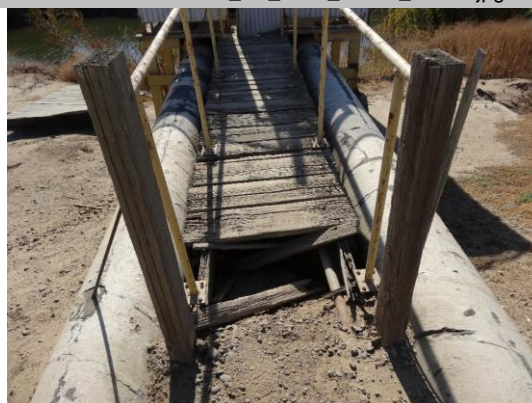
Photo 2 of 2 : UCIP\_FA\_2016\_50452\_39186.jpg

WS view: walkway to pumphouse. Walkway in poor condition.

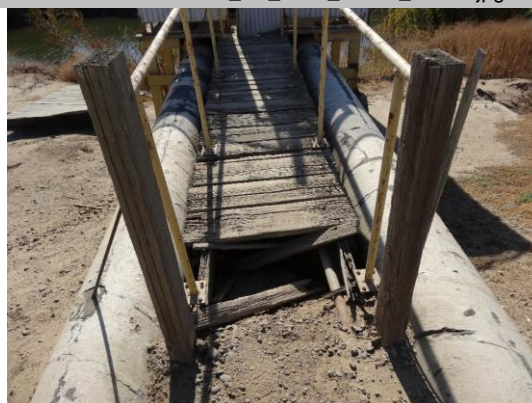
Photo 2 of 2 : UCIP\_FA\_2016\_50454\_39175.jpg

WS view: walkway in poor condition, to pumphouse.

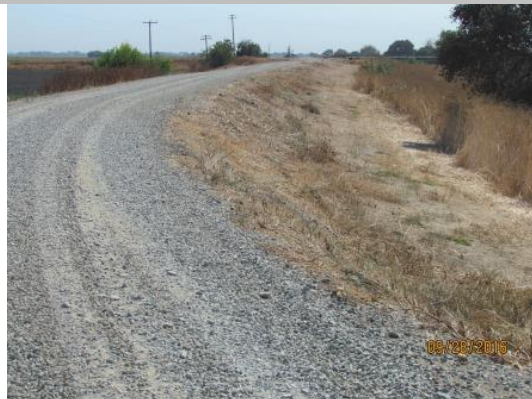
Photo 1 of 1 : FA\_2016\_RD2062\_310\_11\_20160929\_00030.jpg

View of the vegetation on the waterside levee slope.

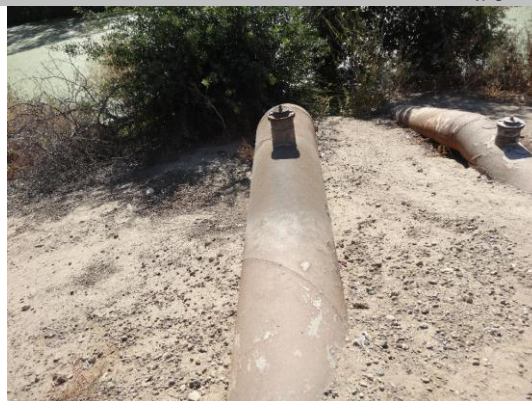
Photo 1 of 2 : UCIP\_FA\_2016\_23304\_40147.jpg

LM Start	3.24	Rating **	M	Issue No.	17
LM End	3.24	Issue Type +	En	Location *	WS
Category	Supplemental			GPS Latitude/Longitude	
				Start	End
Item	DWR UCIP Field Study			37.804770 °	37.804770 °
				-121.379679 °	-121.379679 °
DWR ID					
Comment Code					
Inspector Comment					
FS_ID:23304					
DS_ID:19199					
EP_NO: 11524					
Repair Type: Non-Urgent					
Crossing Status: Found					
UCIP Comments: - waterside pipe immersed into channel water.-					
most of the pipe on landside exposed and siphon breaker on waterside					
not protected.					
FIELD_STRUCT_DESC: 1 of 3: One of 2x24-inch pipes through the					
levee 2.0 feet below the crown. 18-inch pipe through the levee 4.0 feet					
below the crown. Siphon breakers on waterward slope. Pump on steel					
platform in drainage ditch, 350 ft. from levee center off the the landward					
berm. (App. No. 11524)					
FS Date: 10/22/2013

WS view: 24-inch steel pipe (left) with siphon breaker on levee slope. 18-inch pipe on right.

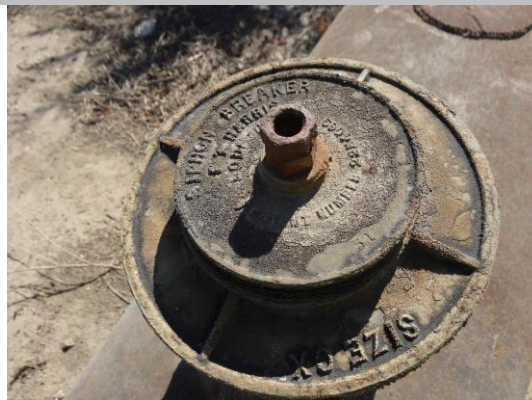
Photo 2 of 2 : UCIP\_FA\_2016\_23304\_40146.jpg

WS view: leaky siphon breaker on levee slope.

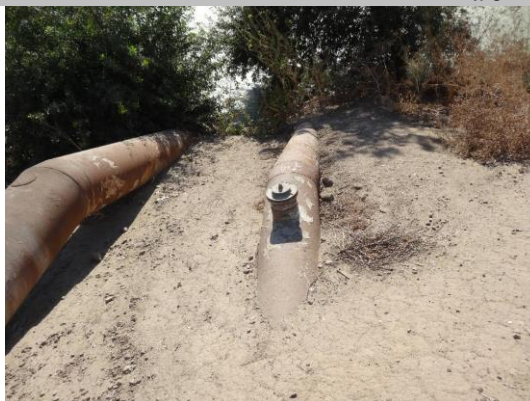
Photo 1 of 2 : UCIP\_FA\_2016\_23023\_39082.jpg

FS\_ID:23023  
DS\_ID:19198  
EP\_NO: 11524  
Repair Type: Non-Urgent  
Crossing Status: Found  
UCIP Comments: - 18-inch pipe bifurcated near the pump and two gate valves installed.- waterside pipe immersed into channel water.- most of the pipe on landside exposed and siphon breaker on waterside not protected.  
FIELD\_STRUCT\_DESC: 2 of 3: 18-inch pipe through the levee 4.0 feet below the crown. 2x24-inch pipes through the levee 2.0 feet below the crown. Siphon breakers on waterward slope. Pump on steel platform in drainage ditch, 350 ft. from levee center off the the landward berm.  
(App. No. 11524)  
FS Date: 10/22/2013

WS view: exposed 18-inch pipe with siphon breaker on levee slope.  
Exposed 24-inch pipe (left).

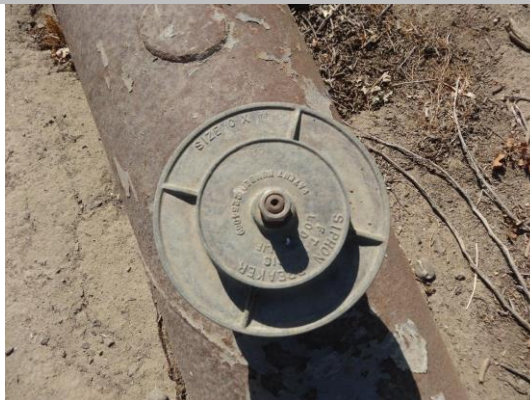
Photo 2 of 2 : UCIP\_FA\_2016\_23023\_39081.jpg

WS view: closer view of 18-inch pipe with siphon breaker on levee slope.

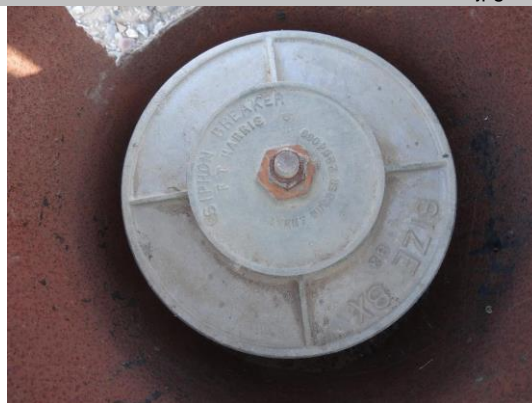
Photo 2 of 2 : UCIP\_FA\_2016\_23305\_40152.jpg

WS view: closer view of siphon breaker in steel pipe riser on levee slope.

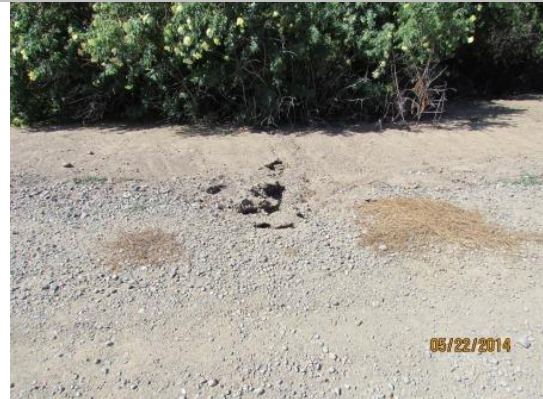
Photo 1 of 1 : FA\_2016\_RD2062\_310\_8\_20160914\_00002.jpg

LM Start	3.64	Rating **	M	Issue No.	8
LM End	3.64	Issue Type +	Ma	Location *	WS
Category	Earthen Levee			GPS Latitude/Longitude	
				Start	End
Item	Erosion / Bank Caving			37.806347 °	37.806347 °
				-121.386692 °	-121.386692 °
DWR ID	DWR_RD2062_02_s_2014_8				
Comment Code					
E2 : Schedule repair of erosion site prior to the next inspection.					
Inspector Comment

View of the erosion from surface runoff on the waterside levee slope.

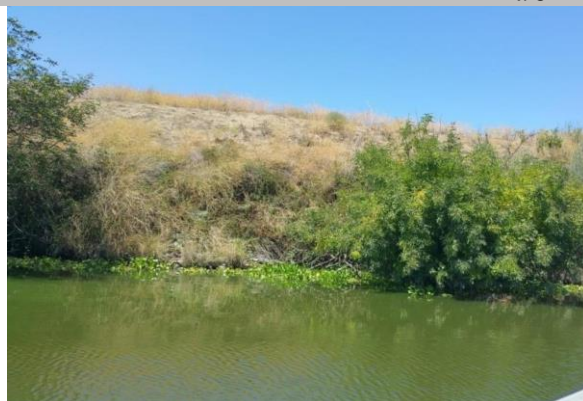
Photo 1 of 2 : SJR2016\_RD2062U03RM29.93\_1.jpg

LM Start	-0.04	Rating **	U	Issue No.	1
LM End	0.06	Issue Type +	Ma	Location *	WS
Category	Supplemental			GPS Latitude/Longitude	
				Start	End
Item	DWR Erosion Survey			37.809414 °	37.809414 °
				-121.390328 °	-121.390328 °
DWR ID					
Comment Code					
Inspector Comment					
07/25/2016: No significant change observed.					
06/25/2015: No significant change observed.					
07/02/2014: No significant change observed.					
08/13/2013: No significant change observed.					
08/07/2012: The site has been visited by boat survey. No significant change observed					
08/23/2011: Site is at the upstream of a drainage ditch. [2016 Site ID:RD2062U03RM29.93]

Front view of the erosion.

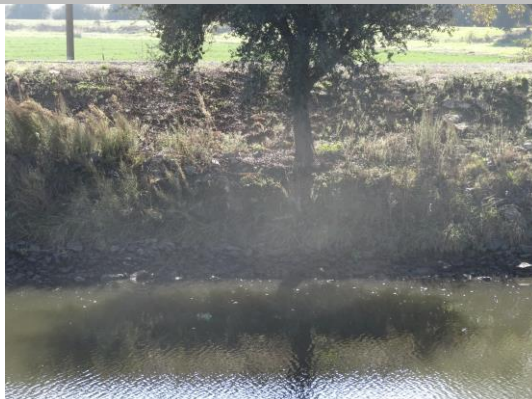
Photo 1 of 2 : SJR2016\_RD2062U03RM29.94\_1.jpg

LM Start	0.02	Rating **	M	Issue No.	2
LM End	0.03	Issue Type +	Ma	Location *	WS
Category	Supplemental			GPS Latitude/Longitude	
				Start	End
Item	DWR Erosion Survey			37.809514 °	37.809514 °
				-121.390125 °	-121.390125 °
DWR ID					
Comment Code					
Inspector Comment					
11/09/2016: No significant change observed.					
06/25/2015: The erosion is below a large oak tree. Vegetation is visible around the erosion site. [2016 Site ID:RD2062U03RM29.94]

Front view of the erosion site. Note the large tree above the erosion.

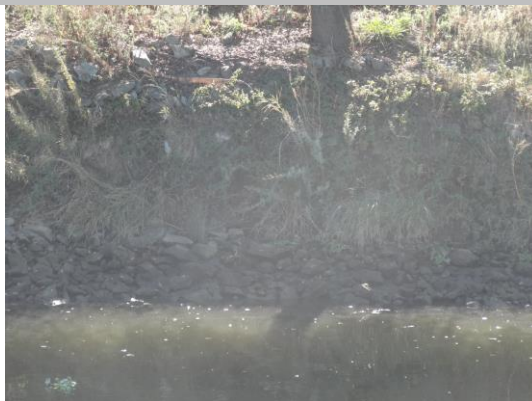
Photo 2 of 2 : SJR2016\_RD2062U03RM29.94\_3.jpg

Close view of the erosion.

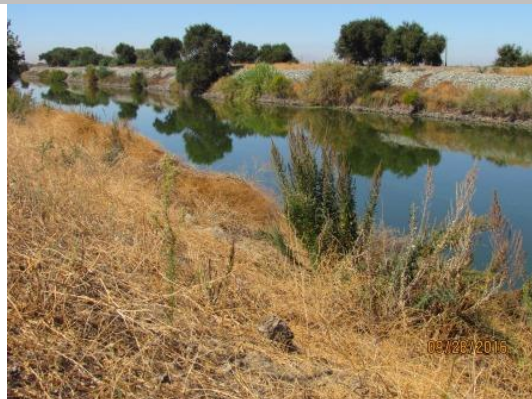
Photo 1 of 1 : FA\_2016\_RD2062\_311\_6\_20160929\_00059.jpg

View of the tree stump on the waterside levee slope.

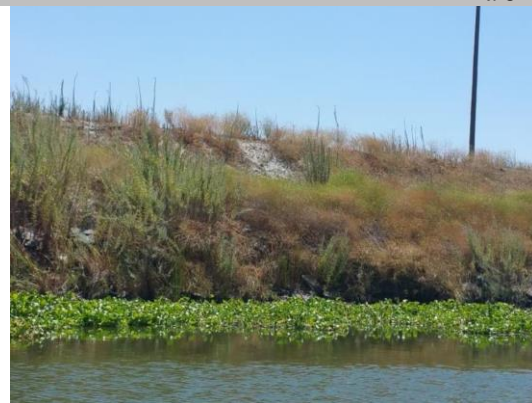
Photo 1 of 2 : SJR2016\_RD2062U03RM30.1\_1.jpg

LM Start	0.17	Rating **	M	Issue No.	5
LM End	0.17	Issue Type +	Ma	Location *	WS
Category	Supplemental			GPS Latitude/Longitude	
				Start	End
Item	DWR Erosion Survey			37.810268 °	37.810268 °
				-121.387495 °	-121.387495 °
DWR ID					
Comment Code					
Inspector Comment					
07/25/2016: No significant change observed.					
06/25/2015: No significant change observed.					
07/02/2014: No significant change observed.					
08/13/2013: No significant change observed.					
08/07/2012: The site has been visited by boat survey. No significant change observed					
08/23/2011: The protection at the levee toe has been washed away.					
[2016 Site ID:RD2062U03RM30.1]

Direct view of the site.

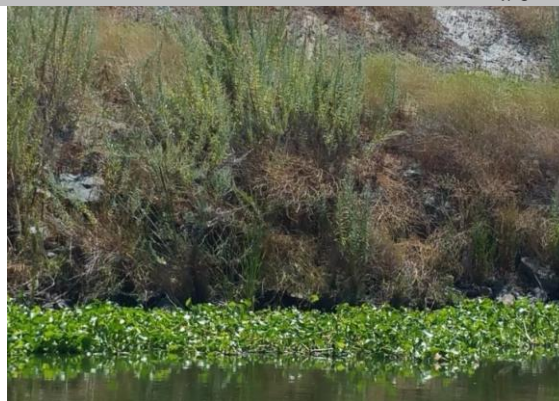
Photo 2 of 2 : SJR2016\_RD2062U03RM30.1\_2.jpg

LM Start	0.17	Rating **	M	Issue No.	5 (cont)	
LM End	0.17	Issue Type +	Ma	Location *	WS	
Category	Supplemental			GPS Latitude/Longitude		
				Start	End	
Item	DWR Erosion Survey			37.810268 °	37.810268 °	
				-121.387495 °	-121.387495 °	
DWR ID						
Comment Code						
Inspector Comment						
07/25/2016: No significant change observed.						
06/25/2015: No significant change observed.						
07/02/2014: No significant change observed.						
08/13/2013: No significant change observed.						
08/07/2012: The site has been visited by boat survey. No significant change observed						
08/23/2011: The protection at the levee toe has been washed away.						
[2016 Site ID:RD2062U03RM30.1]

Close view of the erosion.

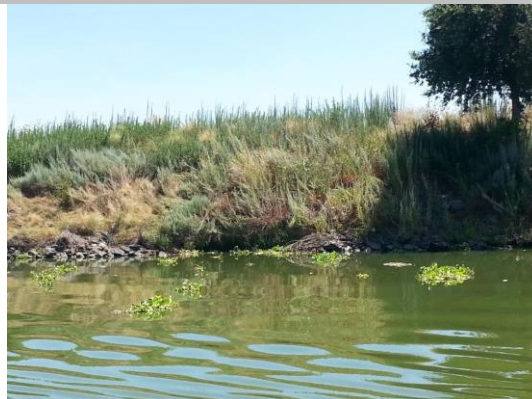
Photo 1 of 1 : SJR2016\_RD2062U03RM30.19\_2.jpg

07/25/2106: No significant change observed. More vegetation observed at the site.  
 06/25/2015: No significant change observed.  
 07/02/2014: No significant change observed.  
 08/13/2013: A new pocket erosion at the upper levee slope has been found directly above a large tree. The erosion might have been caused by internal pipe leakage or surface runoff.  
 08/07/2012: The site has been visited by boat survey. No significant change observed  
 08/23/2011: No significant change observed on site. Dense vegetation is visible along the water line.  
 09/07/2010: No significant change observed on site. Much of the upper slope was recently cleared of vegetation by spraying. 4- to 6-foot vertical scarp and pocket erosions are lined along a span of 475 feet. In some sections, the vertical scarp encroaches into the levee prism. There is a lack of berm along this reach, exposing the levee slope to high flow velocities during normal and flood events.

08/06/2010: Recommended as local maintenance issue, per CLRO.  
 03/09/2010: As discussed with Michael Moncrief of MBK Engineers, the site will be 'addressed' later this year.  
 09/29/2009: No major change observed since last visit; pocket erosion and a vertical scarp forming; this site was combined with Site RM30.13 and 30.02 with a combined total erosion length of 475 feet; recommended as annual assessment and monitoring of the site, per CLRO CES Evaluation 2008 Report; previously rated "M".  
 11/05/2008: Top of vertical scarp has rip rap that appears to be sliding; rodent holes; existing toe rip rap. [2016 Site ID:RD2062U03RM30.19]

Close view of the pocket erosion. Note the dense vegetation at the site.

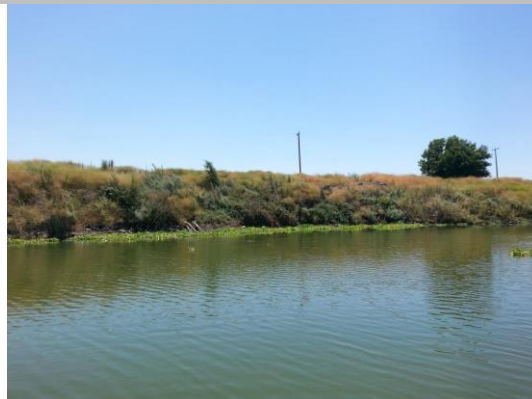
Photo 1 of 3 : SJR2016\_RD2062U03RM30.27\_1.jpg

Front view of the erosion.

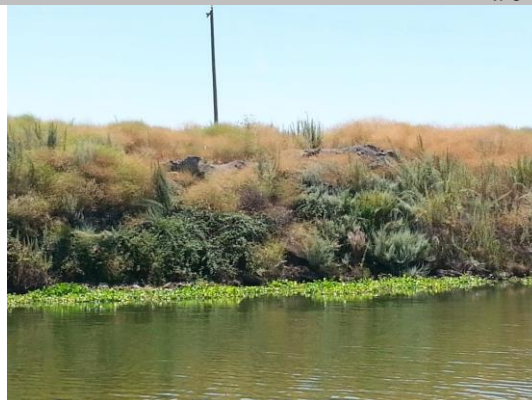
Photo 2 of 3 : SJR2016\_RD2062U03RM30.27\_2.jpg

Close view of the site. Note the dense vegetation at the site.

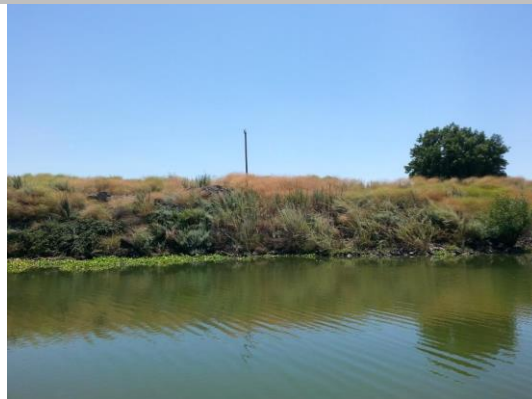
Photo 3 of 3 : SJR2016\_RD2062U03RM30.27\_3.jpg

Front view of the erosion.

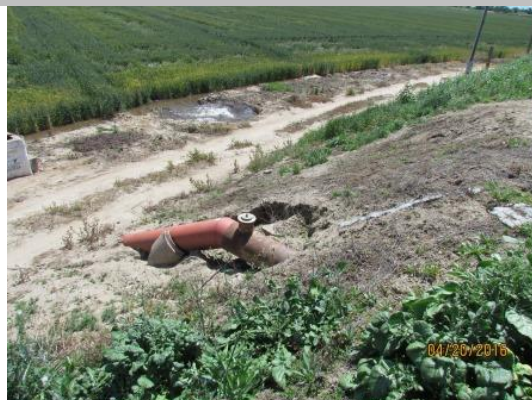
Photo 1 of 1 : FA\_2016\_RD2062\_311\_38\_20160914\_00039.jpg

View of the landside levee slope erosion around the pipe.

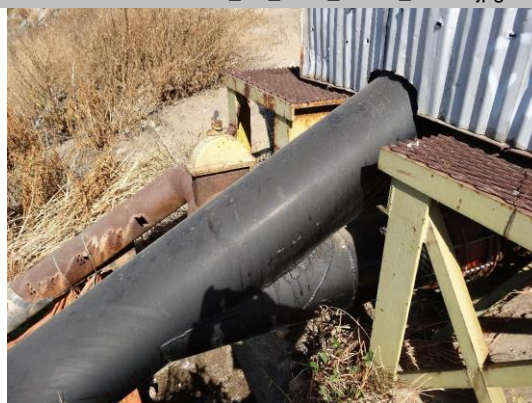
Photo 2 of 2 : UCIP\_FA\_2016\_50455\_40157.jpg

WS view: pump house on levee slope and holes-pits on corroded overflow pipe (left).

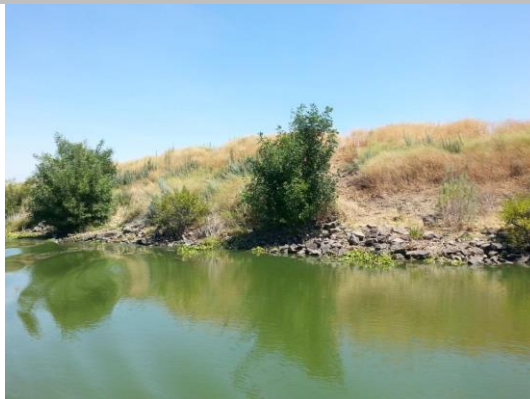
Photo 1 of 2 : SJR2016\_RD2062U03RM30.43\_2.jpg

Front view of the site. Previously placed rip rap slipped, exposing the underlying soils and creating a pocket.

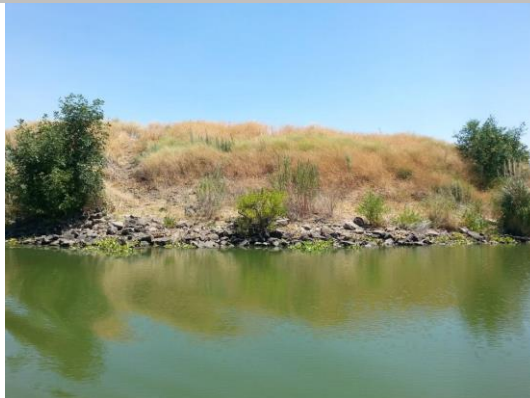
Photo 2 of 2 : SJR2016\_RD2062U03RM30.43\_3.jpg

Front view of the site. Rip rap is no longer adequately protecting levee slope.

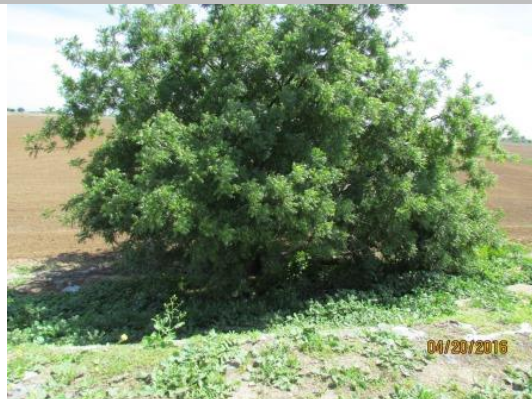
Photo 1 of 1 : FA\_2016\_RD2062\_311\_36\_20160914\_00038.jpg

View of the tree at the landside levee toe.

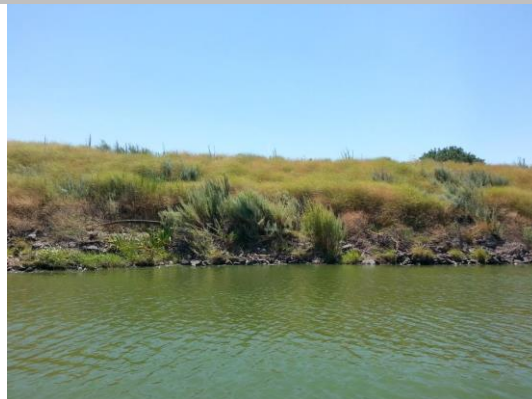
Photo 1 of 1 : SJR2016\_RD2062U03RM31.12\_2.jpg

Front view of the site.

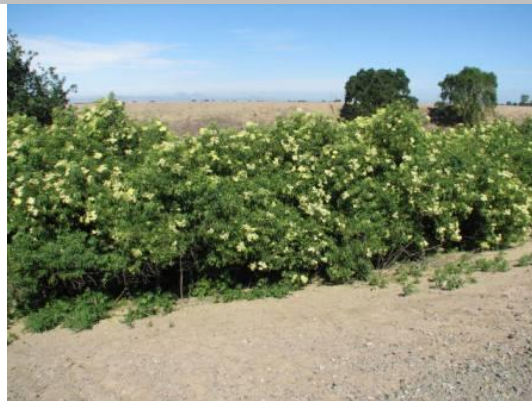
Photo 1 of 1 : FA\_2016\_RD2062\_311\_18\_20160914\_00029.jpg

05/11/2011 Elderberry bush on water side slope.

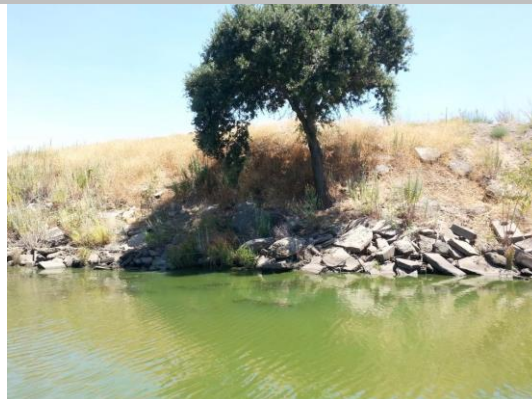
Photo 1 of 2 : SJR2016\_RD2062U03RM31.28\_1.jpg

Front view of the erosion site.

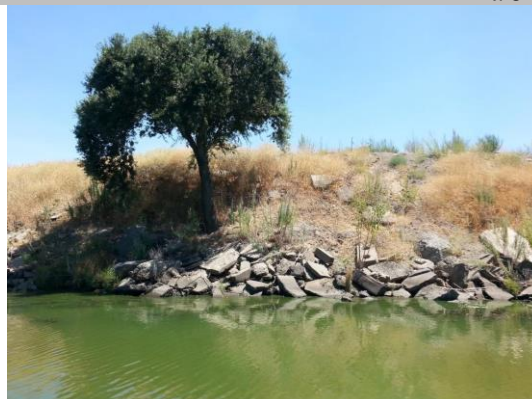
Photo 2 of 2 : SJR2016\_RD2062U03RM31.28\_3.jpg

Front view of the site. Note the existing broken concrete on the upper levee slope as well as on the lower slope and at the toe.

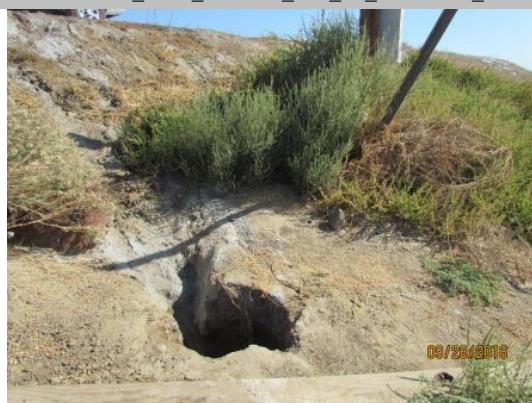
Photo 1 of 1 : FA\_2016\_RD2062\_311\_40\_20160929\_00057.jpg

View of the landside levee slope damaged by pipe.

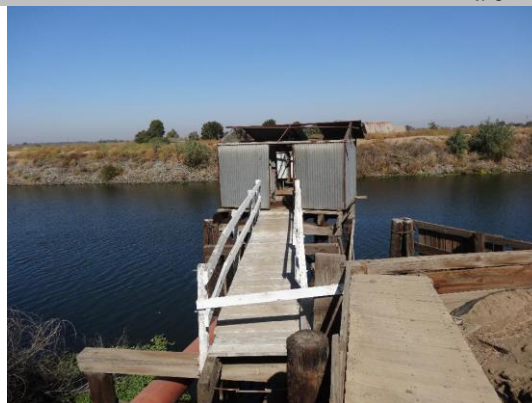
Photo 1 of 2 : UCIP\_FA\_2016\_23311\_40175.jpg

WS view: wooden walkway to pumphouse, pumphouse on wooden pile structure in the stream.

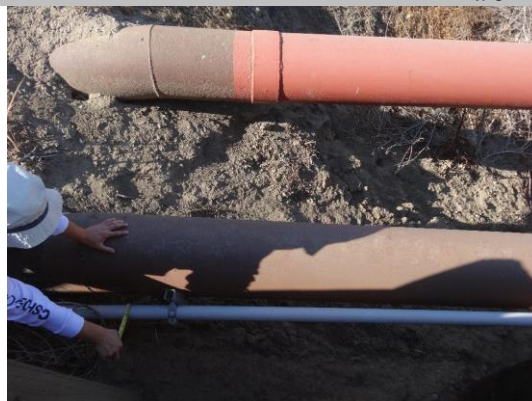
Photo 2 of 2 : UCIP\_FA\_2016\_23311\_40174.jpg

WS view: exposed steel pipes and an electric conduit on levee slope.

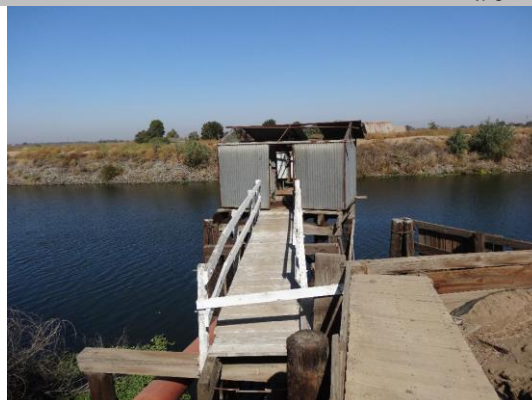
Photo 1 of 2 : UCIP\_FA\_2016\_23312\_40181.jpg

WS view: wooden walkway to pumphouse, pumphouse on wooden pile structure in the stream.

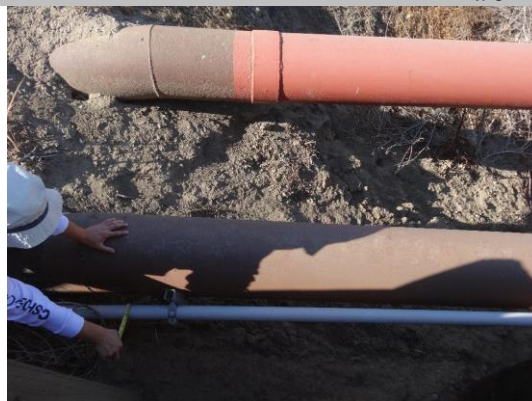
Photo 2 of 2 : UCIP\_FA\_2016\_23312\_40179.jpg

WS view: exposed steel pipes and a electric conduit on levee slope.

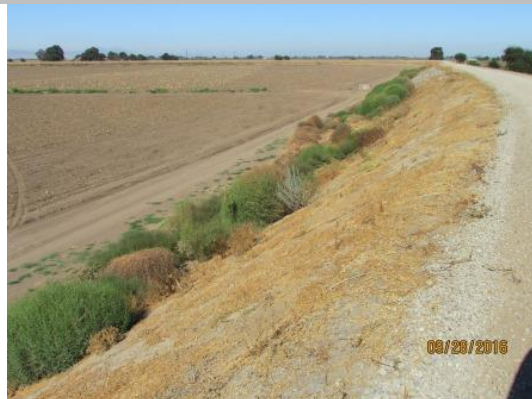
Photo 1 of 1 : FA\_2016\_RD2062\_311\_39\_20160929\_00056.jpg

View of the vegetation at the landside levee toe.

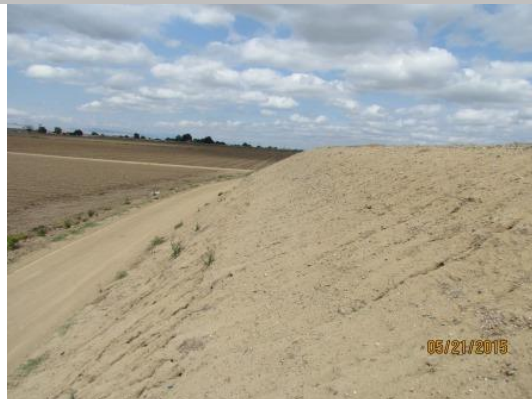
Photo 1 of 1 : FA\_2016\_RD2062\_311\_31\_20160914\_00034.jpg

View of the eroded landside levee toe.

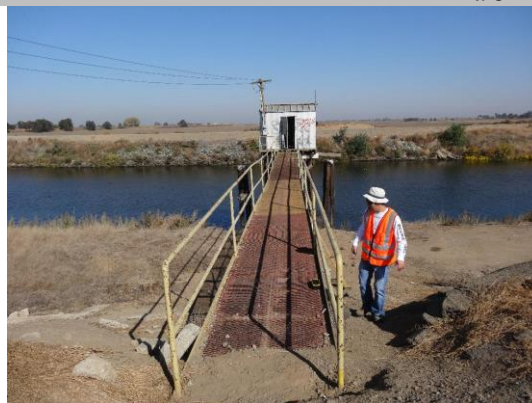
Photo 1 of 2 : UCIP\_FA\_2016\_23142\_39549.jpg

WS view: steel walkway to pump house in the stream.

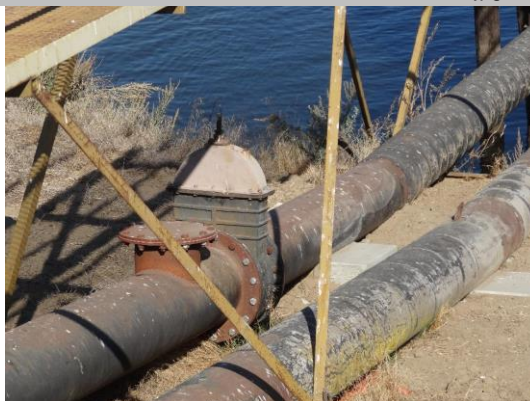
Photo 2 of 2 : UCIP\_FA\_2016\_23142\_39548.jpg

WS view: two 16-inch pipes under walkway. Gate valve without handle on one of the pipes.

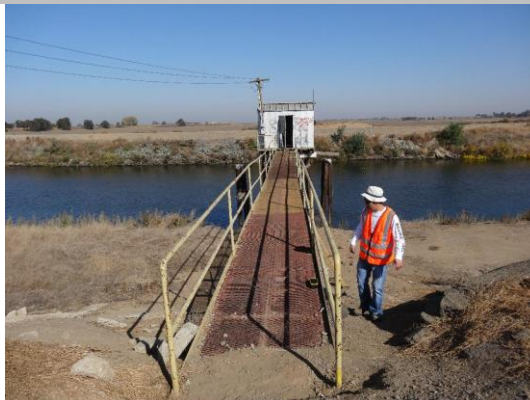
Photo 1 of 2 : UCIP\_FA\_2016\_23140\_39531.jpg

WS view: steel walkway to pump house in the stream.

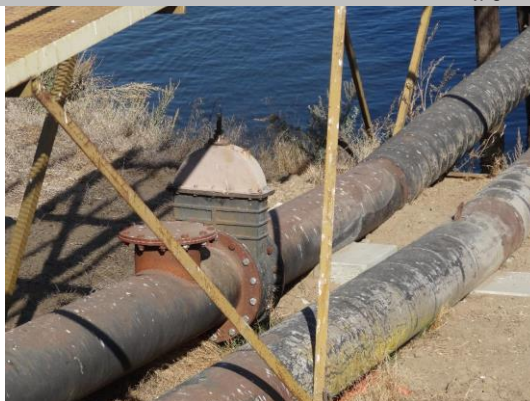
Photo 2 of 2 : UCIP\_FA\_2016\_23140\_39530.jpg

WS view: two 16-inch pipes under walkway. Gate valve without handle on one of the pipes.
